IKARUS C42B: BIG wheel axle

All IKARUS C42 B with the new BIG brake, serial numbers 0302-6476 to 0405-6604 and a gusset plate 5 mm thick.

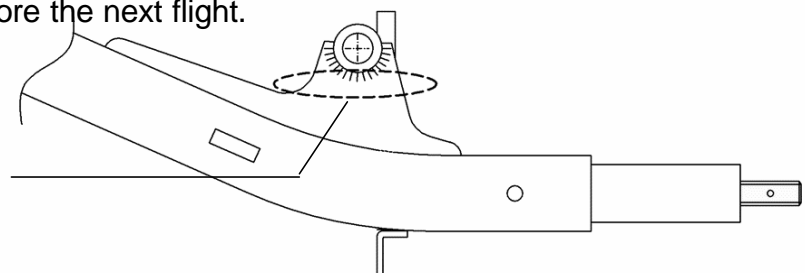
A gusset plate connecting the wheel axle to the shock absorber has ruptured on a wheel axle with the new BIG brake and a gusset plate 5 mm thick. This can result in a failure of the main landing gear.

Check this area for cracks

In order to carry out the inspection, the wing must be lifted and the lower M10 hexagonal bolt of the shock absorber loosened. The examination must be carried out using a magnifying glass with a tenfold enlargement. Should cracks be found, the wheel axle must be replaced before the next flight.

After completing the inspection, the screw should be re-tightened with a torque of approx. 20 to 25 Nm. The work may be carried out by a qualified person.
