IKARUS C42 Safety belt attachment.

All IKARUS C42 up to and including all built until 04/2001 with release fittings in the shoulder harness.

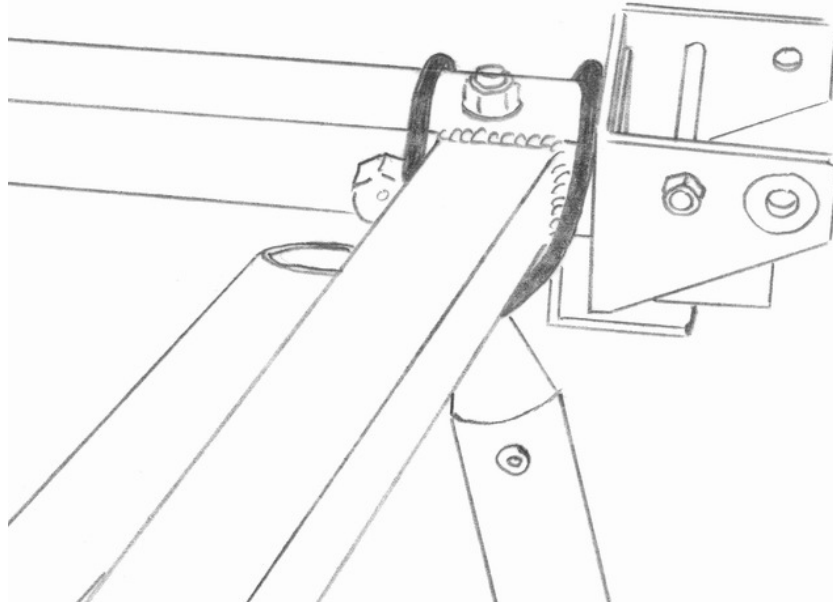
Front view

The shoulder harness attachments broke in an accident with an IKARUS C42 aircraft.

Replacement of the upper shoulder harness attachments through the steel wire loops which are available as a retro-fit kit.

The steel wire (1) must be fed from front to back under the longitudinal tube (2) and over the traverse tube. Both ends of the steel wire are then fed down and under each side of the C strut. Under the C strut the wire thimbles are connected via the release fitting (5). The M8 nut (6) in the longitudinal tube (2) is then covered with the accompanying plastic cap.
