IKARUS C42: Rudder bellcrank.

All IKARUS C42 up to and including 9701-6022, January 1997.

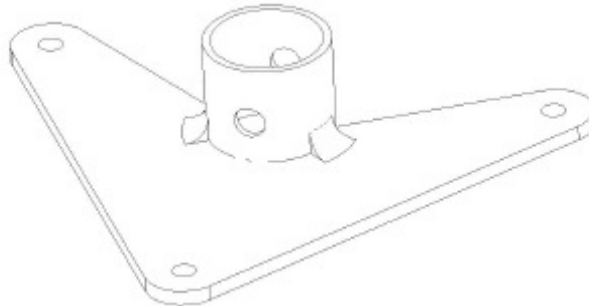
During the inspection of a C42, a crack was discovered in one of the welded joints on the topside of the rudder bellcrank.

Check the welded joints on the topside and underside for cracks

If cracks are detected, the affected part must be replaced before the next flight.
