Rear roof frame attachment, welded U-fitting, connection at B- and C-Strut

all aircraft of the type IKARUS C42

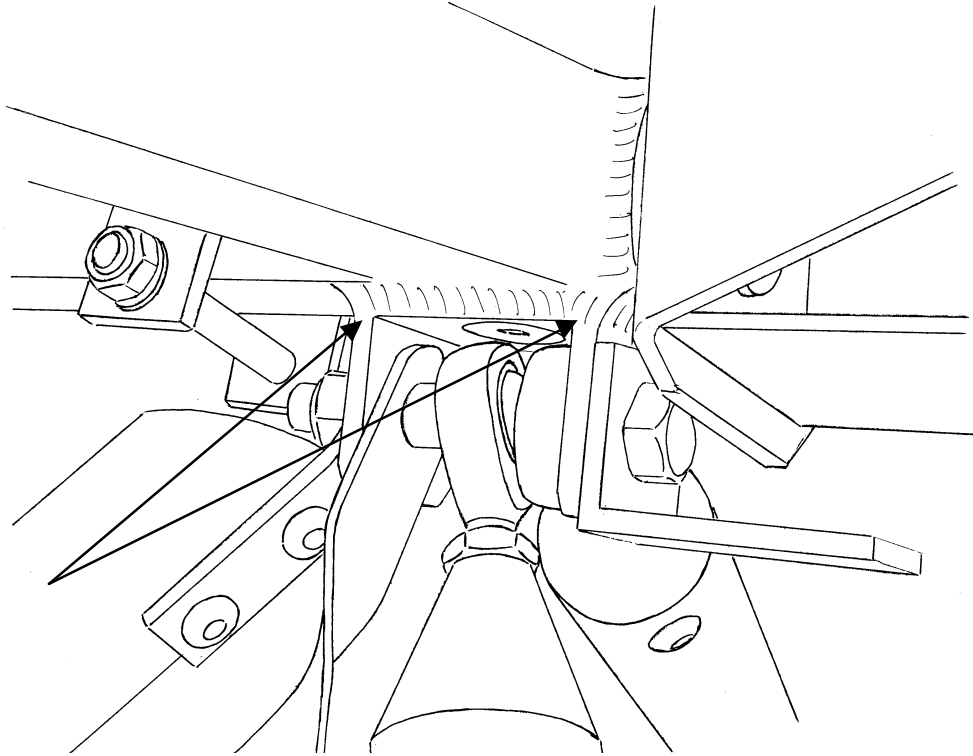
Both flanges of one of the U fittings welded to the roof frame were found to have broken on one IKARUS C42 aircraft.

1. Visual check for cracks in the vicinity of the flange roots of the U fitting. Pos.1

2. Check M8 bolt, Pos. 2 for proper fitting. Torque 20-25 Nm

3. If necessary, replace roof frame
