IKARUS C42 and C42B: Elevator bearing block.

All IKARUS C42 and C42B with an aluminium elevator bearing block.

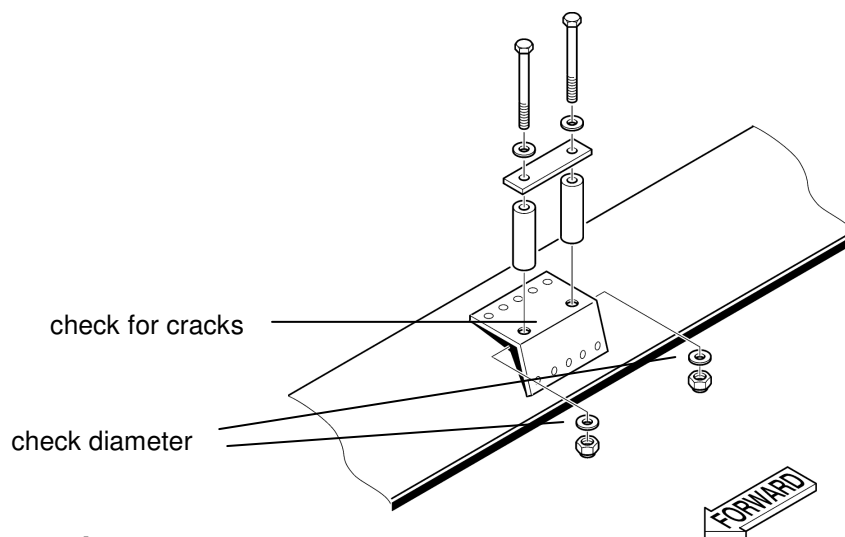
Cracks have been discovered in the elevator bearing blocks of two IKARUS C42B aircraft.

1. Carry out a visual inspection of the elevator bearing block for cracks in the area of the crease. If cracks are found, replace the elevator bearing block.
2. Check the diameter of the washer (2/3 inch or 1/2 inch) under the elevator bearing block. If the washer's diameter is less than 17 mm (2/3 inch): remove the polyamide limit spacers and carry out a visual inspection of the area around the screw-holes for cracks. Replace the washers with V2A "body washers". If cracks are found, replace the elevator bearing block.
3. Include the inspection for cracks in the vicinity of the crease in the normal 50 hour inspection.

If the attachment screws of the polyamide limit spacers are removed, they must be replaced by new M6 stop nuts.

Torque: approx. 13 - 15 Nm.
