IKARUS C42 and C42B: Rudder pedal.

All IKARUS C42 and C42 B with serial numbers up to and including 0603-6799.

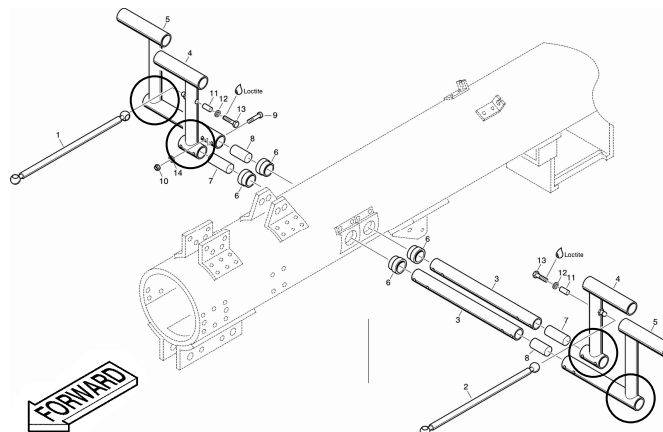
The left co-pilot rudder pedal of a C42 broke during taxiing.

Check the marked areas
for cracks

1. Check the welded joint at the base of the pedal for cracks according to the instructions given below.
2. Inclusion of this check in the normal 50 hour inspection.
3. If necessary, replace affected pedal.

To carry out the inspection, release the pedal push-rods and, after checking the front side, fold the pedals towards the seat, in order to inspect the rear. If cracks are detected, the affected pedal must be replaced before the next flight.
