Subject:

IKARUS C42 and C42B: Rudder pedal, part number 42A14.01b and 42A14.02b

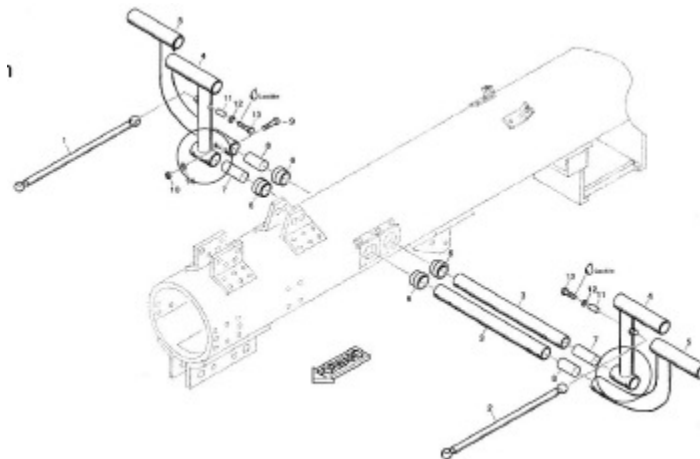
Due to the high forces affecting the rudder pedals, it has been decided to include their inspection in the 100 hrs inspection and the annual inspection, respectively.

Check the welded joint at the base of the pedal for cracks according to the instructions given below.

Check the marked areas for cracks

To carry out the inspection, disconnect the pedal push-rods and, after checking the front side, fold the pedals towards the seat, in order to inspect the rear. If cracks are detected, the affected pedal must be replaced before the next flight.

Replacement pedals, part number 42A14.01b and 42A14.02b, used since April 2006, are available from COMCO IKARUS.
