Front Strut 42A-06.00

Ikarus C42 and C42 B equipped with floats.

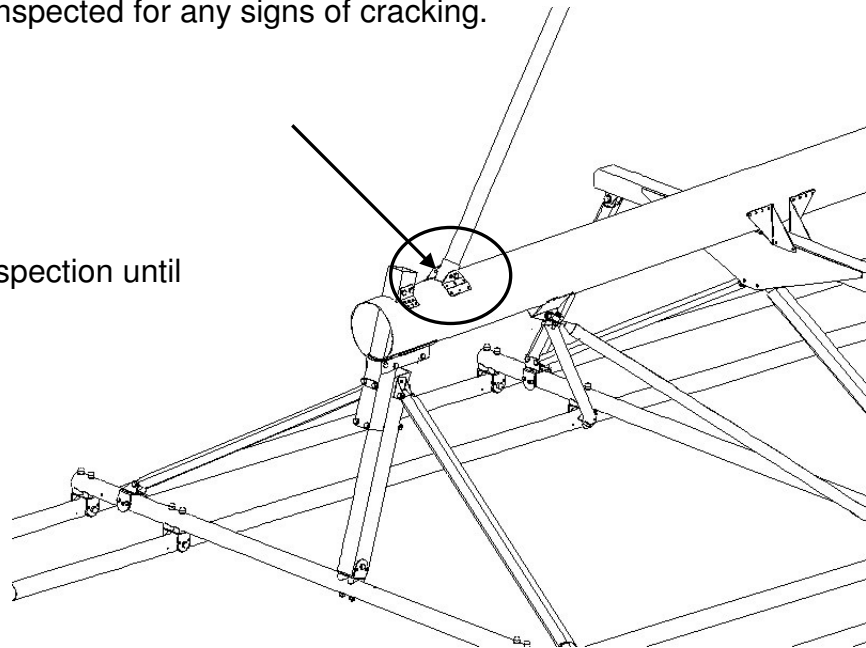
On two IKARUS C42 Floatplanes with previous accidents cracks have been found at the front strut's upper connection to the main tube. The crack occurs on the inner tube where it is covered by an outer sleeve and is not visible from the outside.

To check the front strut a borescope is needed with a 90° field of view. The borescope can be inserted into the front strut through the opening visible from beneath the aircraft. At the height of the bolt marked on the drawing the aluminum tube must be carefully inspected for any signs of cracking.
