SERVICE BULLETIN

SB-42-016-2013 Elevator Bearing Block

Inspection of elevator bearing block and exchange of the Polyamide distances.

All IKARUS C42 and C42 B to serial number 1301-7234

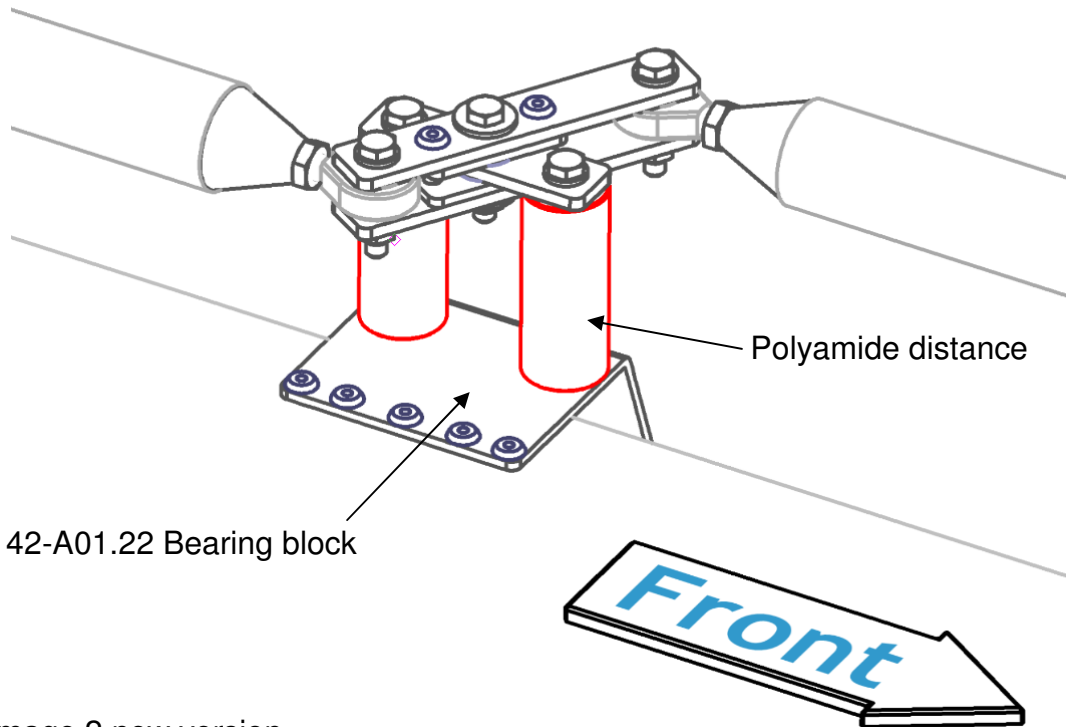
Image 1 previous version

By overloading on the ground (support on stick or elevator) or by clearance in the elevator linkage, the Polyamide distances can cause cracks in the bearing block.

Inspection of elevator linkage on stiffness and straightness of the Polyamide distances. Visual inspection of the elevator bearing block for cracks in the area of the bend. When in doubt, remove the screws securing the Polyamide distances for free accessibility of the bearing block.

Recommended: replacement of Polyamide distances by 42-A15.15A "stop distance elevator balance "(page 3: images 1 and 2)
When cracks are found in the bearing block: exchange the elevator bearing block.
For this purpose, knock out the steel cores of the rivets into the main tube with a punch and drill out the rivets.
The bearing block must be replaced with part 42-A01.22 "bearing block elevator pushrod" and riveted to the main tube.
For this purpose, the included high-strength blind rivets are to be used.
For assembling, new self-locking nuts must be used.
Then the elevator deflections are to be checked upward and downward.
If necessary, the elevator pushrods shall be re-adjusted and secured.
