SERVICE BULLETIN

SB-42-022-2019 Rev. 1 Inspection of A-pillar at C42 A/B/E-Series with A-pillar passing through fuselage tube (C42A up to Serial No.: 1604-7449 C42B up to Serial No.: 1503-7383 C42E up to Serial No.: 1804-7529)

Date published: July 2019

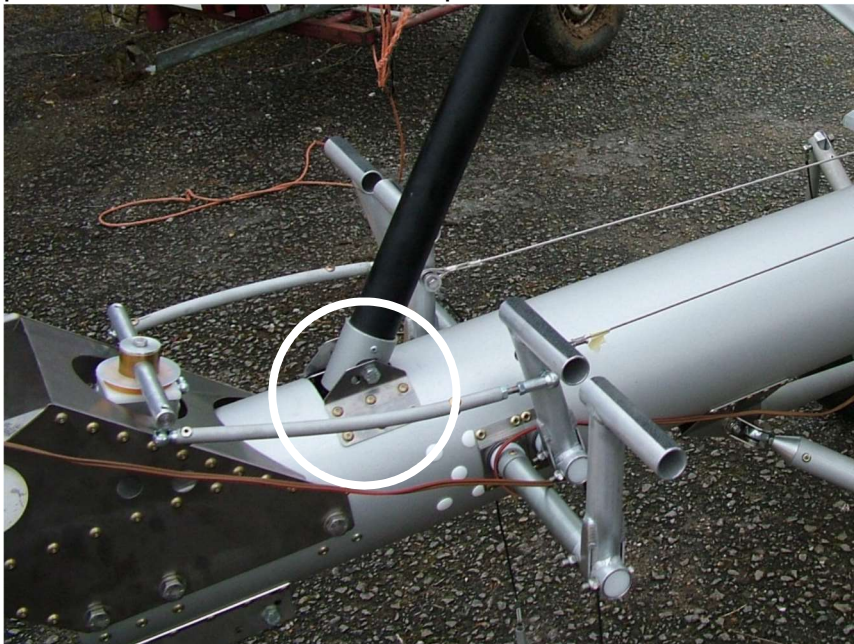
An aircraft with severe cracking of the main fuselage tube emanating from the upper cut-out for the A-pillar was also found to have suffered severe cracking of the A- pillar around its entire circumference. This was hidden within the outer sleeve positioned at the connection between the A- pillar and the upper surface of the main fuselage tube. The load path was maintained by the single small rivet used to locate the outer sleeve on the A- pillar. See Figures 1 & 2.

It is believed that the cracking was a result of excessive loads placed upon the A- pillar due to the near-failure of the main fuselage tube. One other similar historical case is known to have occurred abroad, on an aircraft known to have suffered landing gear damage.

However, it is also possible that the cracking may also be related to fatigue due to flexing of the A- pillar at this point. Therefore inspection on high-hours aircraft is recommended, as well as those which have suffered damage which could have applied excessive loads to the A- pillar.

Figure 1: A- pillar attachment to upper surface of main fuselage tube. Lower attachment bolt visible beneath main fuselage tube at aft end of bracket attached to nose leg.

We recommend visually inspecting the inner surface of the A- pillar in the area where the bolt penetrates the connection to the top of the fuselage tube. The visual inspection must be carried out with an endoscope which can be inserted at the lower end (hole in hull boat behind nose wheel carrier) of the A- pillar. If the cable length of the camera is long enough (more than 1m), the roof can be removed and the endangering spot can be inspected from above. This check has been included in the IKARUS C42 Series Maintenance Manual (Edition VIII) and should be repeated every 300 operating hours after the initial check.

If cracks are found during the inspection, the aircraft **must not be flown**. The A-pillar must be replaced before it is put back into operation.

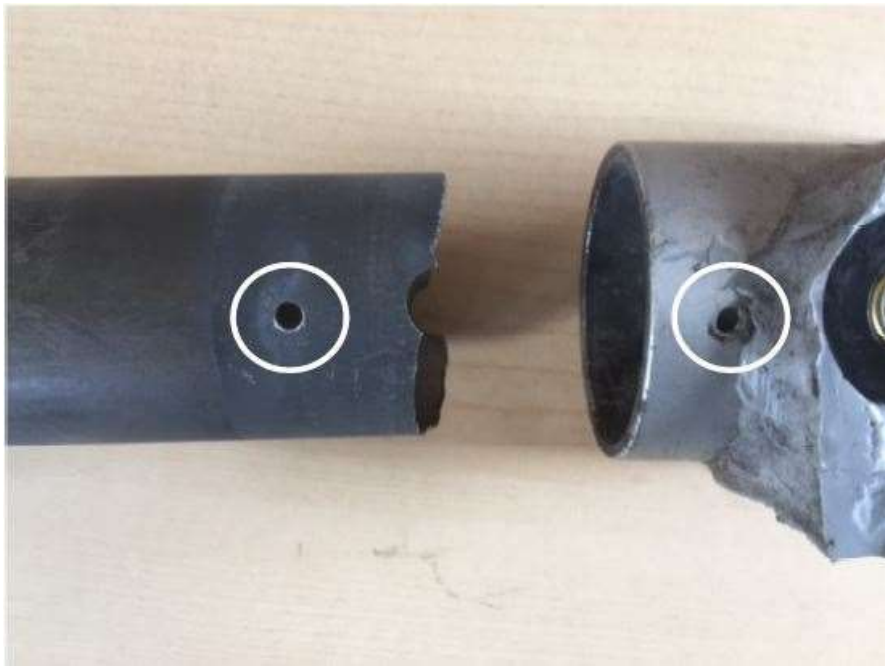
Figure 2: Failed A- pillar removed from outer sleeve part on right of picture. Circled holes show location of the rivet which was holding the parts together.
